Persimmon

Safety Alert

Topic: Tipping Skips

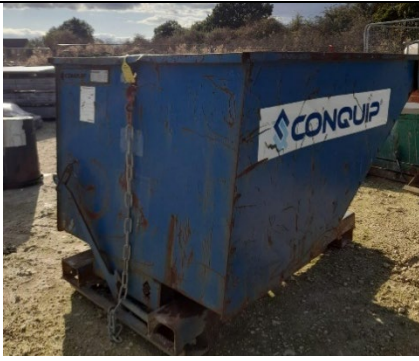
Manual operated skip

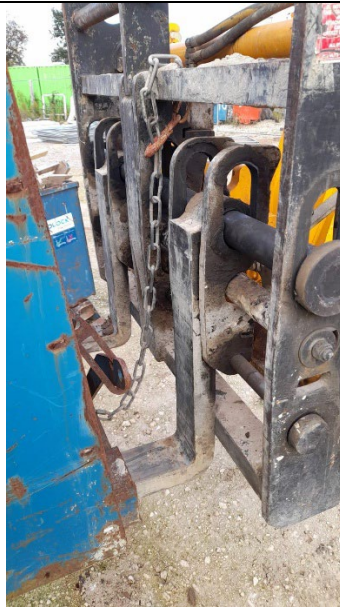
Manual operated skip, showing chain around the forks

- The skip has a current certificate from HSB. Site management must show all lifting equipment, including tipping skips, to the HSB Engineer during their six-month inspections.
- The telehandler operator checks the skips weekly and notes this on their checklist. Any problems should be actioned by the site management.
- A copy of the tipping skip user handbook is on site and the telehandler operator has read and understood it.
- For manually operated tipping skips:
 - It is **ESSENTIAL** to check that the safety catch/ring is engaged at **ALL** times whilst the skip is in use.
 - Skips **MUST NOT** be overloaded.
 - The telehandler operator **MUST** attach the safety chains around the forks and back to the skip. If the safety chain is missing, **DO NOT** use the skip.
- **ONLY** auto-locking tipping skips should be purchased or hired with immediate effect.

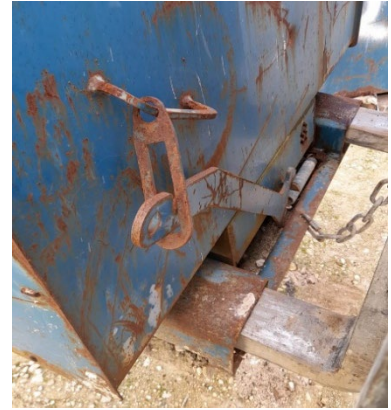
Manual operated skip, showing safety catch

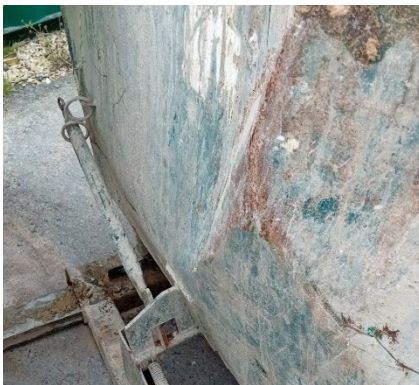
Manual operated skip, showing safety rings

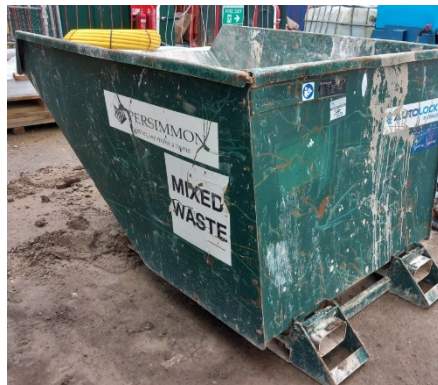
Auto-locking skip, no catch/ rings or chains needed
